Landmarks Commission Staff Report

Re: **Certificate of Appropriateness Petition CA2022-007**

Purpose:
To approve a Certificate of Appropriateness
for the alteration of windows, siding, rear
deck, and front and rear doors.

Property Location:
2924 N. 10th Street
Kansas City, Kansas 66101

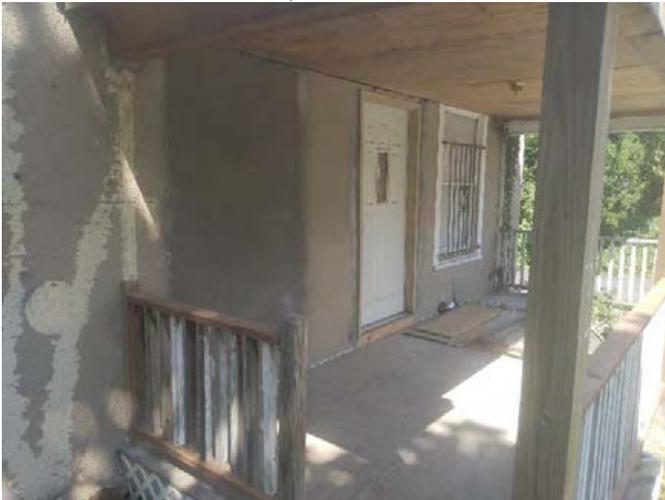
East- Front House 2, door and stucco

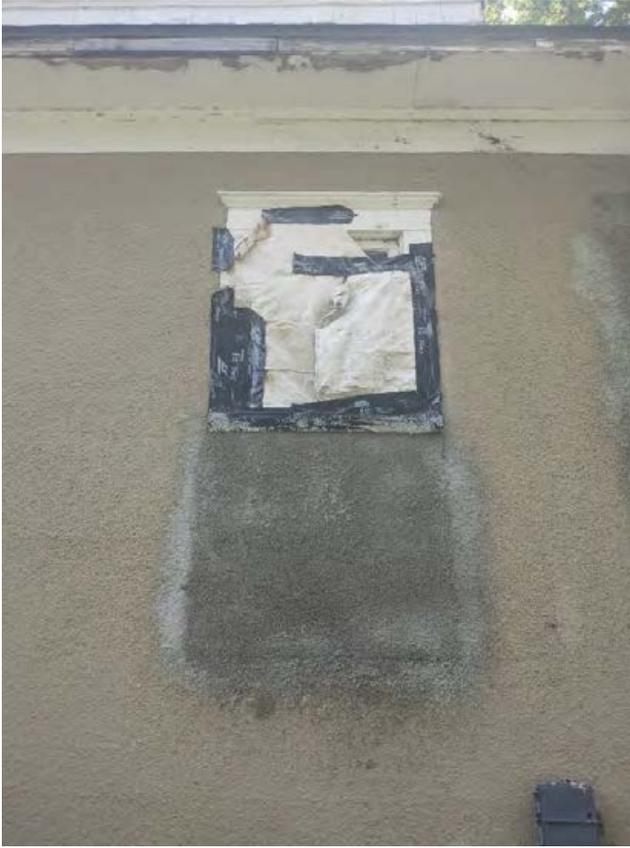
North- modified window

3. One (1) window in each of the North and South facades will be returned or replaced with 1/1 wooden sash windows;
4. The resized window (50%) in the north façade will be kept as is;

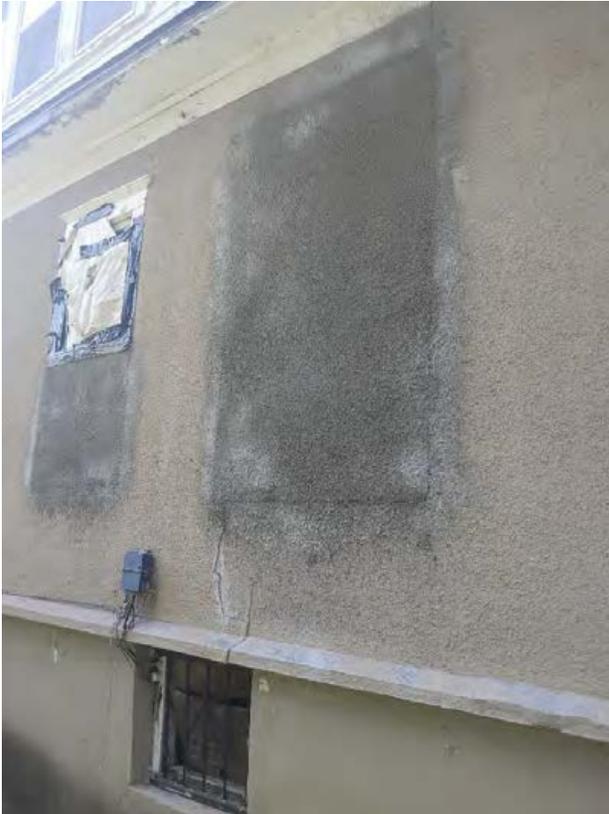
North- Modified windows and covered window

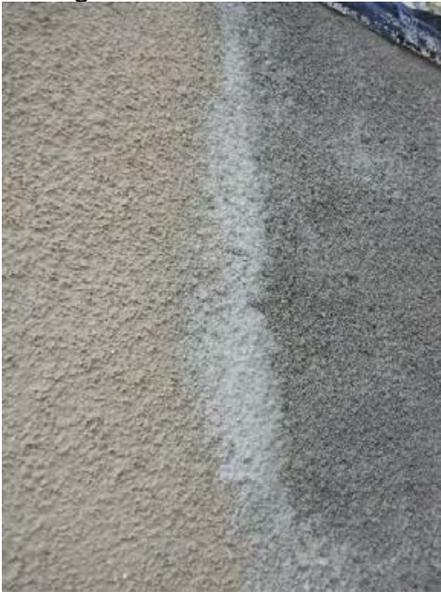
Siding- Stucco contrast

7. The stucco around the first floor of the building will be left as is;
8. The wooden shingle siding in both dormers and on the back mud room will be repaired or replaced in-kind;

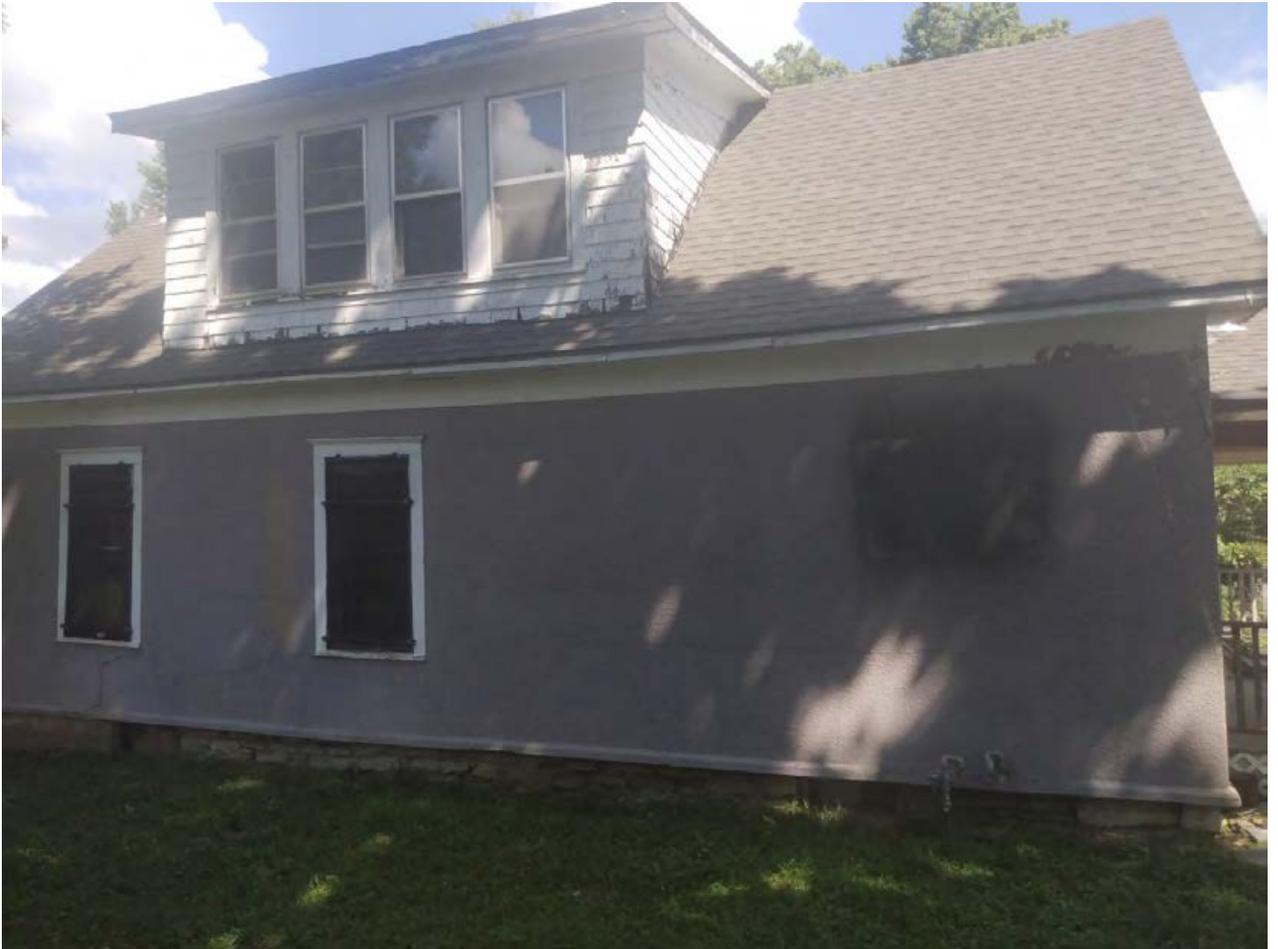
South- Covered window with stucco

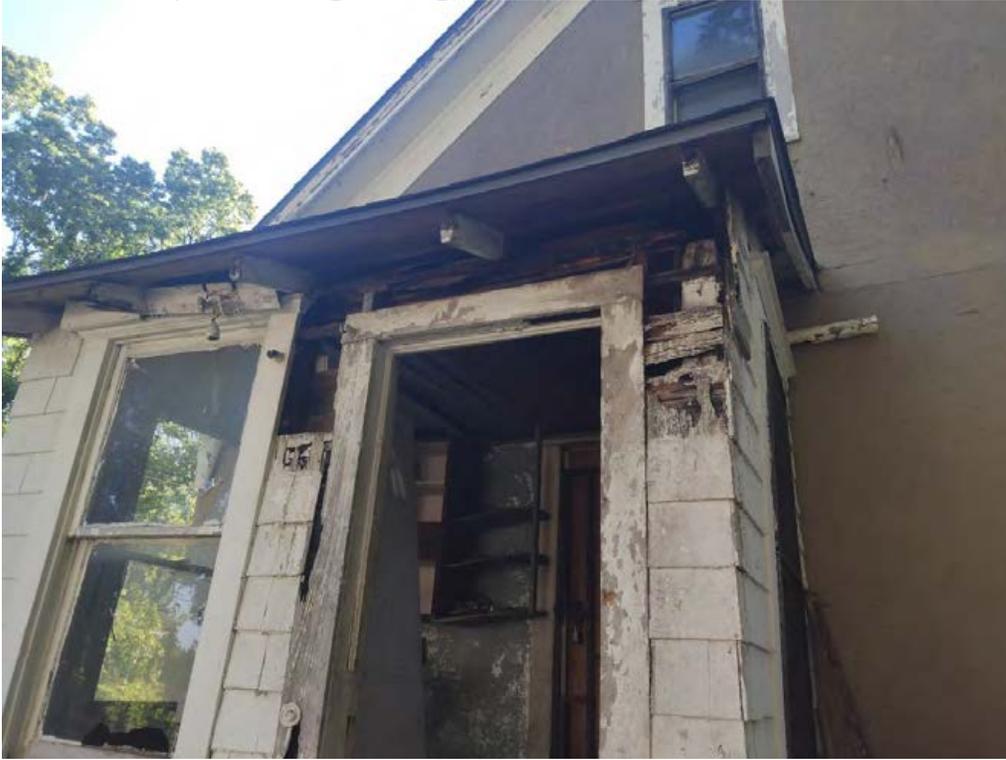
West- Back porch siding damage 1

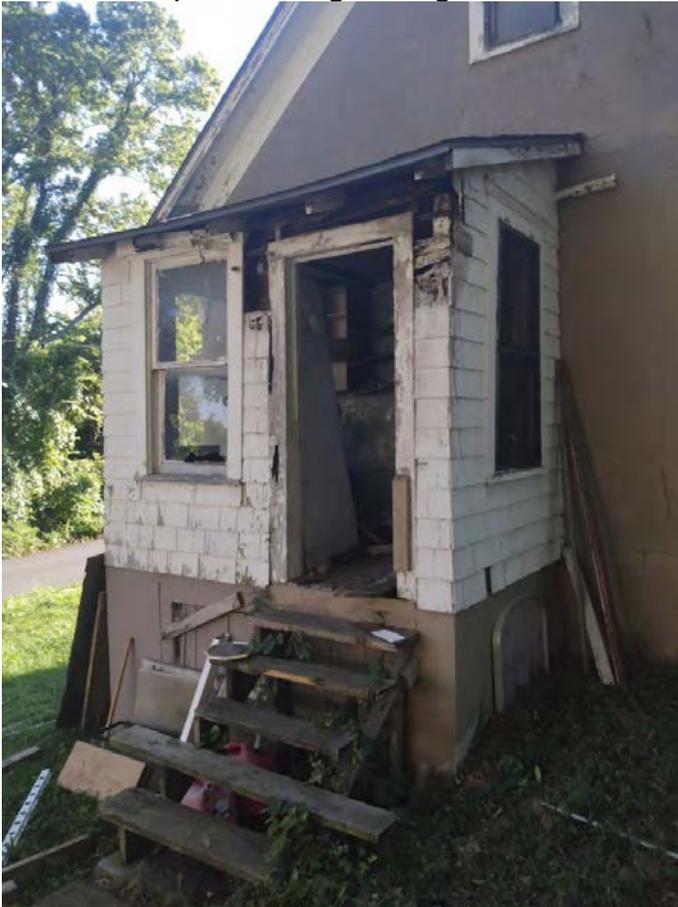
West- Back porch siding damage 2

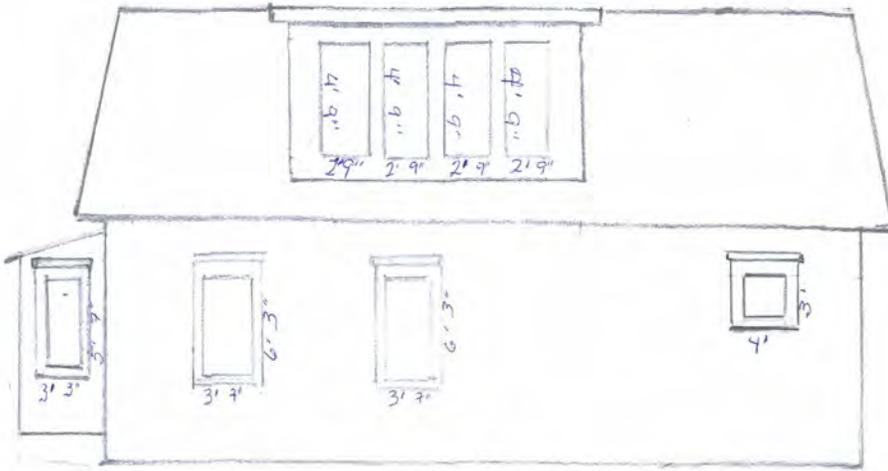
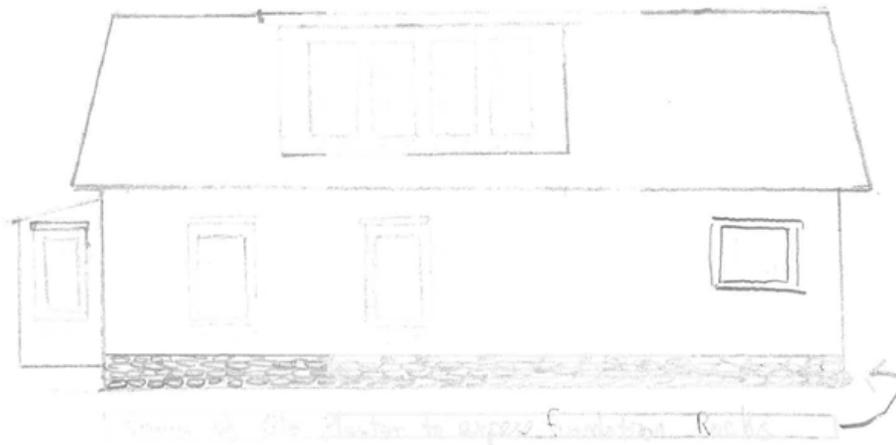
- SOUTH FACING SIDE OF HOUSE / 2924 N. 10TH ST., KANSAS CITY, KS 66104 / OWNER: DIANA SANDRA DAVILA.
- SCOPE OF WORK QUESTIONNAIRE / SECTION III: WINDOWS / QUESTIONS #1, 2, & 4.
- NOTES: (1) No information sheet is available. Please refer to SECTION #7, titled ADDITIONAL INFORMATION. (2) "1" Window was covered. Previous owner matched the siding with Stucco. (3) 3/6 = 1' drawing for reference.

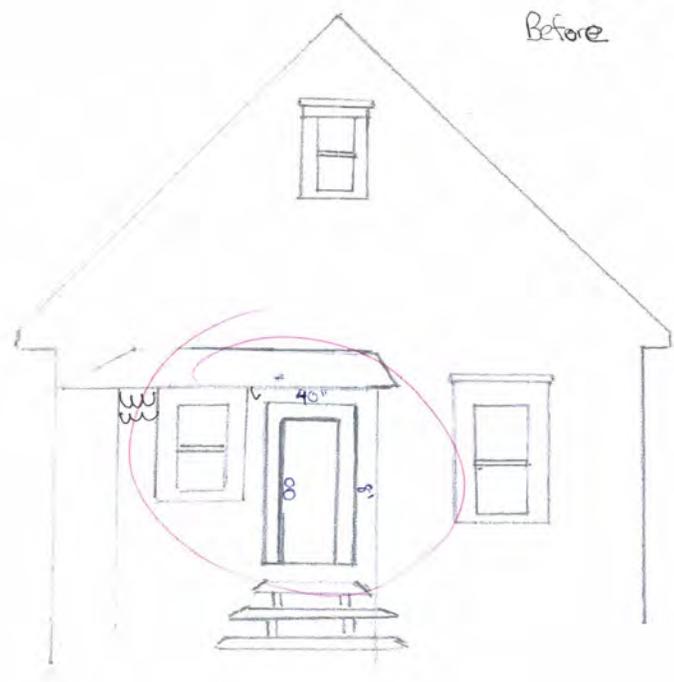
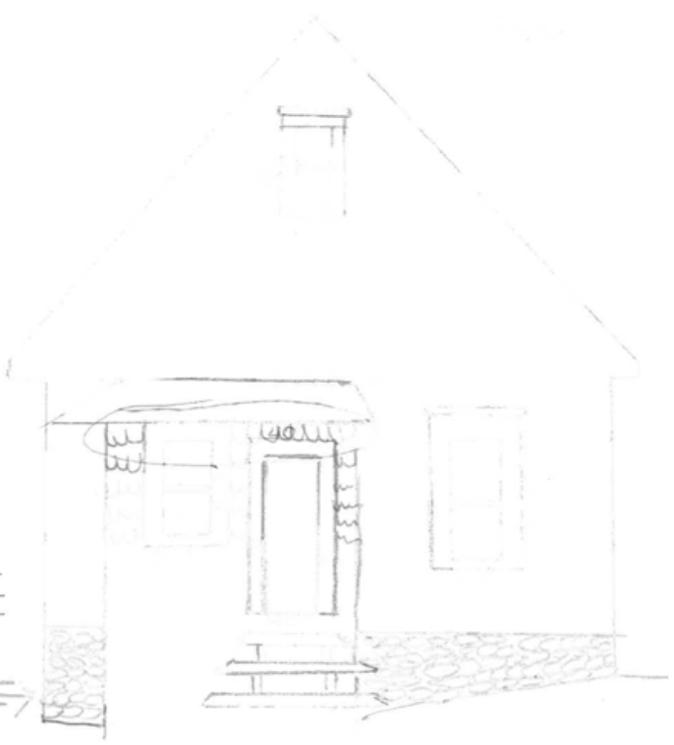
- 1. Door needs to be added to exterior. No door was available when purchased.
- 2. Picture and Spec sheet to be emailed

New single siding
 pieces to be replaced
 Same piece type will
 be used. Area (to be in
 red) shows area of repair
 Pictures to be sent.
 Exterior door to be
 added. Door missing when
 house was purchased as is
 Area of porch area, not
 livable.
 Exterior door is metal &
 36 W x 8 H

Remove or place to expose foundation rocks

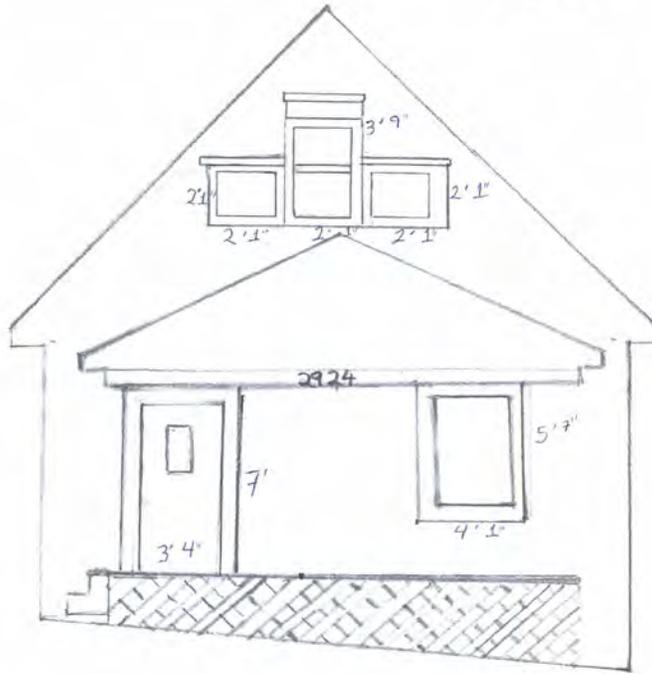
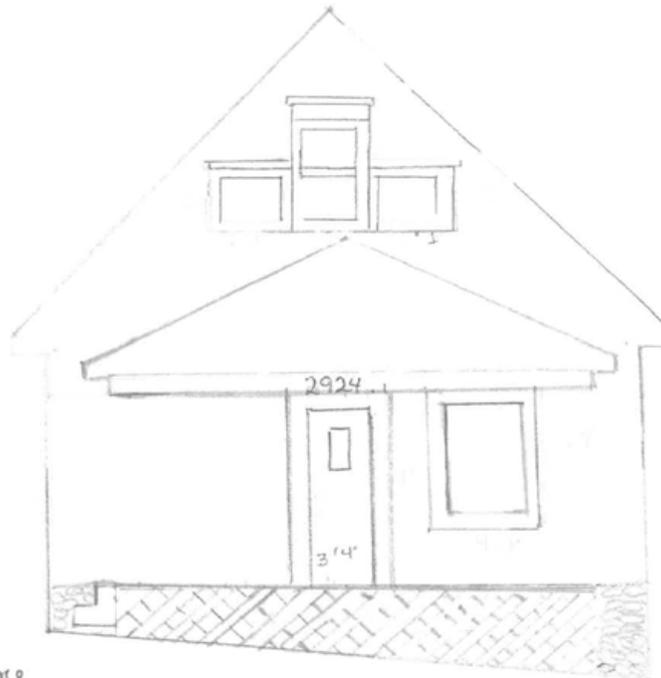
- NOTES:
1. No information sheet is available.
Please refer to SECTION #7, titled
"ADDITIONAL INFORMATION".
2. FRONT VIEW OF HOUSE, FIRST FLOOR,
FRONT PORCH NOT INCLUDED.
3. One front door was moved. Same door
was used.
4. Door Description: Exterior Door H7'XW36".
One Glass Panel included.
5. $\frac{1}{4}$ " = 1' Drawing for reference.

Remove of plaster expose
foundation bricks

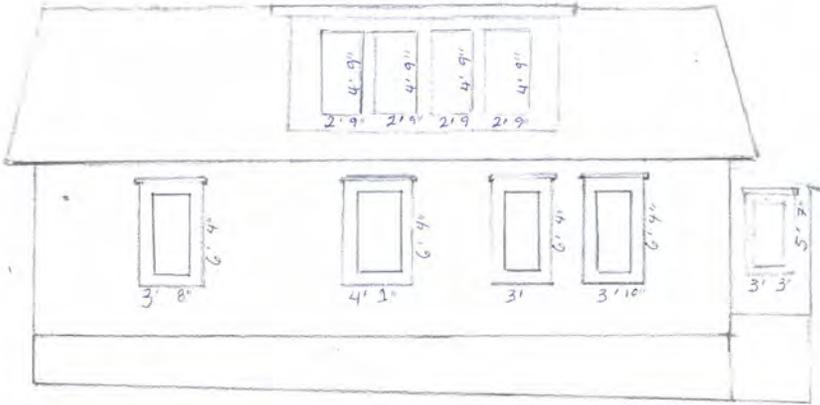
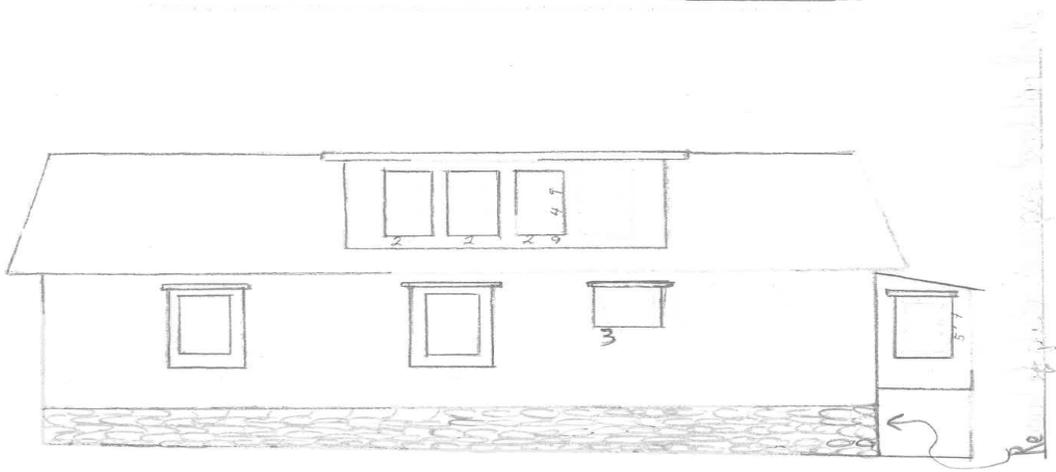
-NORTH FACING SIDE OF HOUSE / 2924 N. 10TH ST., KANSAS CITY, KS 66104 / OWNER: DIANA SANDRA DAVILA.
-SCOPE OF WORK QUESTIONNAIRE / SECTION III: WINDOWS / QUESTIONS #1, 2, & 4. CONTINUED
-NOTES: (1) No information sheet is available. Please refer to SECTION #7, titled ADDITIONAL INFORMATION. (2) "1" Window was covered, "1" Window's size was reduced by half in size. Previous owner matched the siding with Stucco. (3) 3/16 = 1'
